Understanding carbon/epoxy impact damage with infrared thermography

Monitoring online impact tests via the surface-temperature variation of a laminate enables information to be obtained about the initiation and propagation of impact damage.

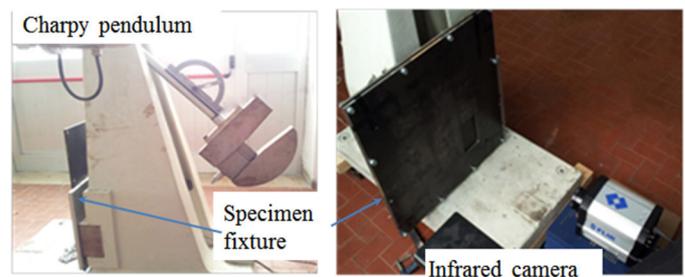
Figure 1. Test rig for investigations into the effect of impact energy on the carbon-fiber-reinforced polymer (CFRP) specimen. The impact energy is set by adjusting the falling height of the Charpy pendulum (left). The infrared (IR) camera (right) is focused on the specimen surface through the window in the lodging plate, and thus acquires thermal images during the impact event.

Charpy pendulum, which allowed enough room for the IR camera to be positioned to the rear of the specimen surface (i.e., opposite the impacted surface): see Figure 1. Each specimen is placed inside a special fixture that includes two large plates. Each plate has a window—with dimensions of 12.5 × 7.5cm—to allow the hammer (attached to the Charpy pendulum) to impact upon the surface of the specimen from one side, and to enable an optical view (for the IR camera) from the other side.
